# FIELD DEMONSTRATION OF A CENTRIFUGAL ULTRA HIGH PRESSURE (UHP) P-19

Contract No. FA4819-07-D-0001

# AIR FORCE RESEARCH LABORATORY MATERIALS AND MANUFACTURING DIRECTORATE

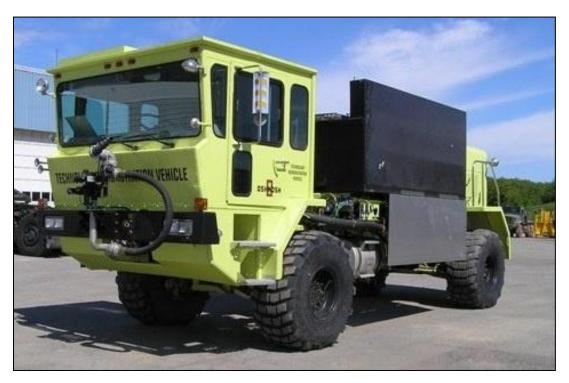
The platform chosen for the CRADA program was an Oshkosh T-1500 fire truck (Figure 1) with a 540 horsepower Detroit Diesel engine, power divider with two power take-offs (PTO), with pump and roll capability referred to as the Technology Demonstrator (TD). Modifications made by Oshkosh to the TD included installation of the UHP system, the CAF system, a combined UHP/CAF bumper turret, UHP and CAF handlines, and associated instrumentation and controls.

Figure 1. The Technology Demonstrator

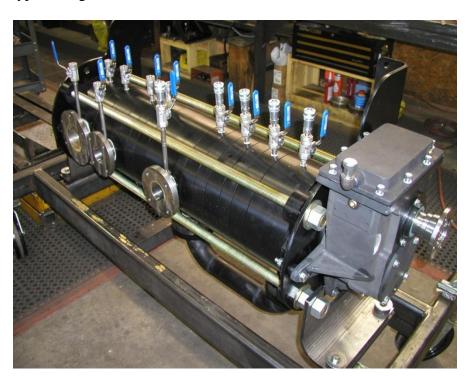
W.S. Darley & Co designed, engineered, fabricated and tested a new six stage centrifugal pump capable of producing low and ultra high pressure with a single pump (Figure 4). The pump specifications for both low and ultra high pressure are shown in Table 1. The first stage provides low pressure while the other five stages build the pressure to UHP. Development started in 2006, and in 2007 Darley finalized a prototype for testing. The first unit was used for testing in the Oshkosh TD. Unfortunately, a problem with a snap ring caused the pump to fail but identified an issue that could easily be addressed in future units. Darley conducted additional testing on the next pump including hydrostatic pressure, high/low pressure performance points, endurance testing, dry run testing, wear component and calculated time to failure to assure reliability and durability. The notes from those tests are provided in Appendix A. Darley has finalized the commercial production of the pump and provided the first five units for retrofit for the field prototype testing.

Figure 4. The Darley Six Stage Centrifugal Pump

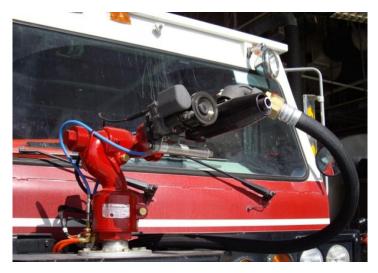
Elkhart Brass has engineered several UHP turret designs that have been tested on the UHP P-19p, Oshkosh TD and UHP P-19c. The most recent design incorporated a single waterway for both UHP and CAF foam Figure 5. The Elkhart Brass Combination UHP and Hydro-Chem<sup>TM</sup> Turret using a sliding plate that positions the selected nozzle in line with the turret waterway. This unique design allowed the turret to sit lower on the bumper, improving the field of view for the vehicle operator while simplifying the plumping and associated hardware. This system was installed on the Tyndall, MH and DM vehicles then later retrofitted on the Dyess and Ellsworth vehicles.

During testing at MH, an engineering defect was found with the UHP nozzle. The pattern selector sleeve broke away from the nozzle while cycling the nozzle from fog to straight stream. Elkhart Brass redesigned the part and performed cycle testing to assure performance. In total, four design modifications were required before the problem was completely resolved. Appendix B contains schematics and correspondence on the resolution to the failure. All five bases have new UHP nozzles with the current design changes incorporated and are functioning properly without any issues.

Figure 5. The Elkhart Brass Combination UHP and Hydro-Chem™ Turret

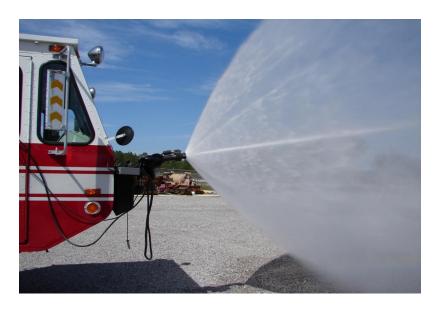
Akron Brass has designed and fabricated several versions of a UHP bumper turret and nozzle system. Originally, Akron Brass focused on the UHP nozzle and did not incorporate the Hydro-Chem<sup>TM</sup> nozzle. The first Akron Brass UHP turret and nozzle, tested on the UHP P-19p in 2006, was very effective and equaled performance to the Elkhart Brass UHP system in foam expansion ratio, drain time and discharge distance. The Akron Brass UHP nozzle had a different fog pattern than the Elkhart Brass nozzle and followed the traditional conical stream pattern (Figure 6). Also, due to the design of the nozzle, a small straight stream of water was discharged simultaneously from the center of the nozzle providing some level of longer range protection. The stream pattern was altered for the system used on the UHP P-19c.

Figure 6. Akron Brass UHP Nozzle in Fog Pattern

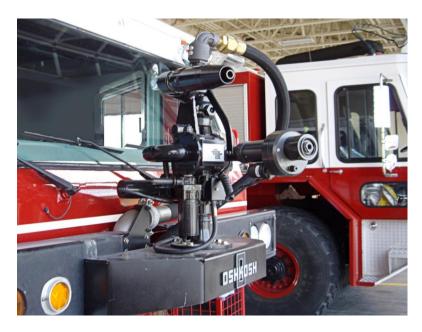
Fig. 7 shows the combination Akron Brass turret that was designed for the UHP P-19c. This system was originally installed on the Tyndall, Dyess and Ellsworth vehicles. Oshkosh was responsible for the design to marry the Hydro-Chem<sup>TM</sup> nozzle to the UHP nozzle so that both nozzles could be controlled with a single motor. Four issues were identified with this design and ultimately led to the replacement of the Akron Brass system with the Elkhart Brass system.

Figure 7. The Combination Akron Brass UHP and Hydro-Chem™ Turret

- The mounting of the Hydro-Chem<sup>TM</sup> nozzle obscured the field of view of the driver/operator, hindering extinguishment performance.
- Another design consideration of the bumper turret is the shape of the water stream in fog pattern. Akron Brass designed the pattern so that it formed a horizontal fan rather the traditional conical pattern. This was done to minimize overspray onto the windshield while improving the field of view of the driver/operator and still providing protection. Careful consideration needs to be made when reattaching or tightening the nozzle to assure the nozzle is in the right orientation otherwise the stream will not be horizontal, which reduces the effectiveness of the fog pattern.

Per the performance specifications in the contract, Oshkosh was notified of these problems and given the opportunity to either correct the Akron Brass system or replace the bumper turret with the Elkhart Brass system. Due to time and cost constraints, Oshkosh chose to replace the Akron Brass system with the Elkhart Brass system.

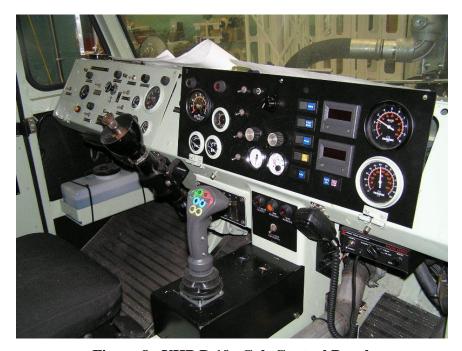
Figure 8. UHP P-19c Cab Control Panel

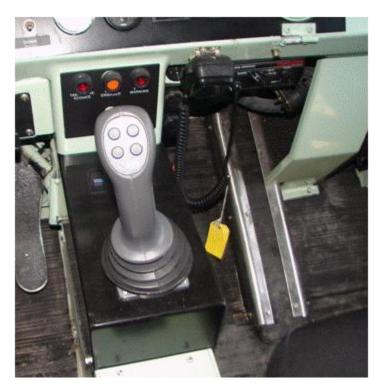
HMA Fire Apparatus and AFRL have been working together on a variable speed joystick controller for the UHP and CAF turret (Figure 9). Current systems only allow the buyer to choose motors with a speed of either fast or slow. Fast motors can quickly overshoot the target while slow motors delay the reaction time of repositioning the turret. The solution was to design a variable speed controlled joystick. The farther the joystick is moved from the spring returned center, the faster the turret moves in the given direction, essentially creating a variable speed turret. The HMA joystick worked with both the Akron Brass and Elkhart Brass bumper turret systems.

Figure 9. HMA Force Feedback Joystick
